## Transmission of SARS-CoV-2 on a Patient Transport Van

We report 2 episodes of potential SARS-CoV-2 transmission from infected van drivers to passengers despite masking and physical distancing. Whole genome sequencing confirmed relatedness of driver and passenger SARS-CoV-2. With the heater operating, fluorescent microspheres were transported by airflow >3 meters from the front to the back of the van.

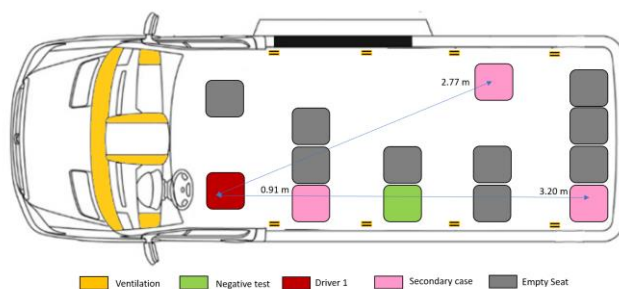
A.

The first driver transported 4 patients on 2-hour trips to and from the hospital on December 2, 2020, one day prior to onset of symptoms (Figure 1.A). The quantification cycle of the driver's nasopharyngeal specimen was 15.9, indicating a high viral burden. The driver and all passengers wore cloth facemasks and only interacted during boarding and transportation. Of 4 passengers tested for SARS-CoV-2, 3 had positive results from nasopharyngeal specimens collected 6 to 8 days after exposure and 1 subsequently developed COVID-19 symptoms.

A and B show a schematic of the van and passenger seating arrangement during the first and second van rides. C shows the genetic variant profiles of the sequenced SARS-CoV-2 relative to the Wuhan-Hu-1 reference genome for 6 SARS-CoV-2-infected individuals from the van rides and for 3 unrelated COVID-19 patients. Clade information was based on Nextstrain, Global Initiative on Sharing Avian Influenza Data (GISAID), and Pangolin lineage. Gradient intensity of the bar indicates the reference allele frequency at each variant nucleotide position.

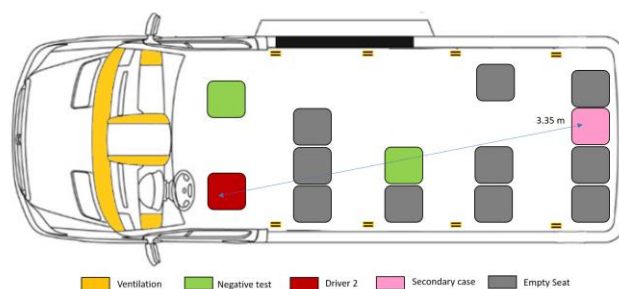
B.

The second driver transported 3 patients on the same 2-hour trip in the same van on January 23, 2021, the day his symptoms began (Figure 1.B). The quantification cycle of the driver's nasopharyngeal swab specimen was 24, indicating a high viral burden. One passenger was diagnosed with COVID-19 4 days later, whereas the other passengers

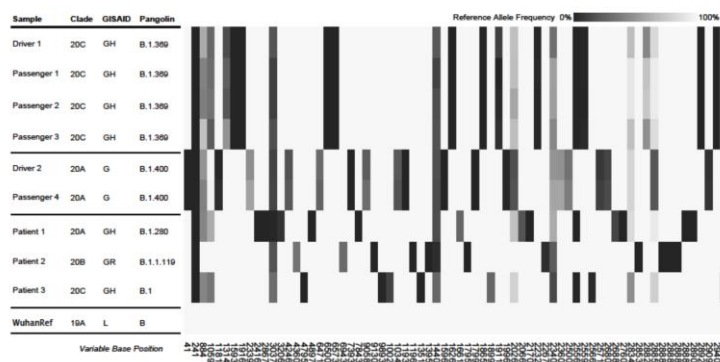
C.

All samples had >99% of the genome covered with a depth greater than 100X. SARS-CoV-2 sequences for each van driver were distinct, whereas passenger sequences for each episode were related to the corresponding driver sequences ( $\leq 2$  base differences based on their variant positions) (Figure 1.C).
